Aviation DOA Nr.: EASA.21J.025	<b>Technische Mitteilung / Service Bulletin</b>	Dokument Nr.: <b>SB-AT01-018</b>
	<b>Muster / Type: AT01</b> <b>Nr. / No.: AT01-018</b>	Ausgabe/Issue: 01 Seite/Page: 1 of 3

## Technische Mitteilung/Service Bulletin AT01-018

### **Nachrüstung eines Kantenschutzes am Hauptfahrwerk** *Retrofit of a edge protection for the Main Landing Gear*

ATA-Chapter 32-10:  
 Introduction of a aerodynamically shaped edge-  
 protection for the main landing gear legs.

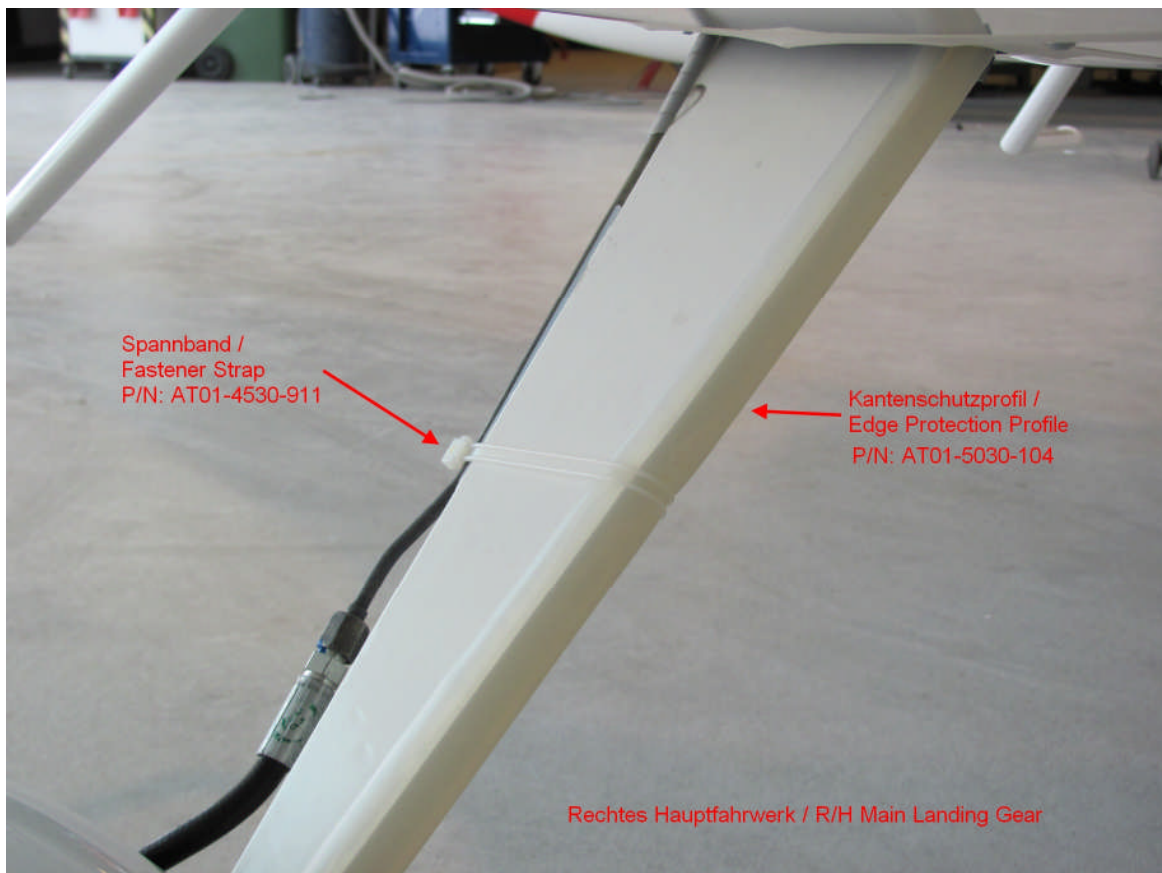
### Installation

Repair/Sealing of stone-chipping damages on the main landing gear legs:

- Sanding of damaged areas (grit 400)
- Cleaning of damaged areas with alcohol
- Priming with 2-component-Epoxy-Primer (automotive market)
- sealing with white (RAL 9016) paint (i.e. repair kit from the automotive market)
