| DOA Nr.: EASA.21J.025 | Technische Mitteilung / Service Bulletin | Dokument Nr.: SB-AT01-030 |

Inspektion des Wasserkühlers auf ausreichend Abstand zur Cowling und eventuelle Beschädigung / Inspection of water radiator for sufficient spacing and possible chafing damage

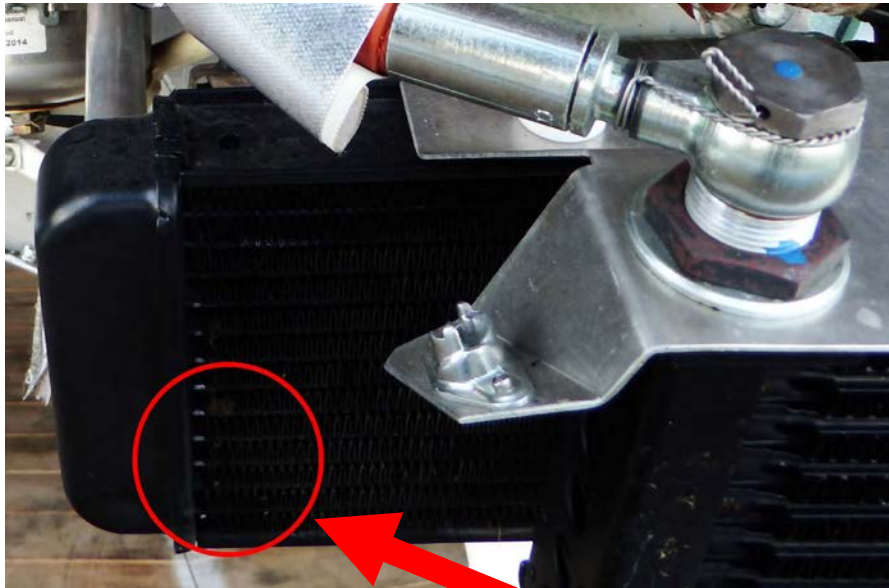
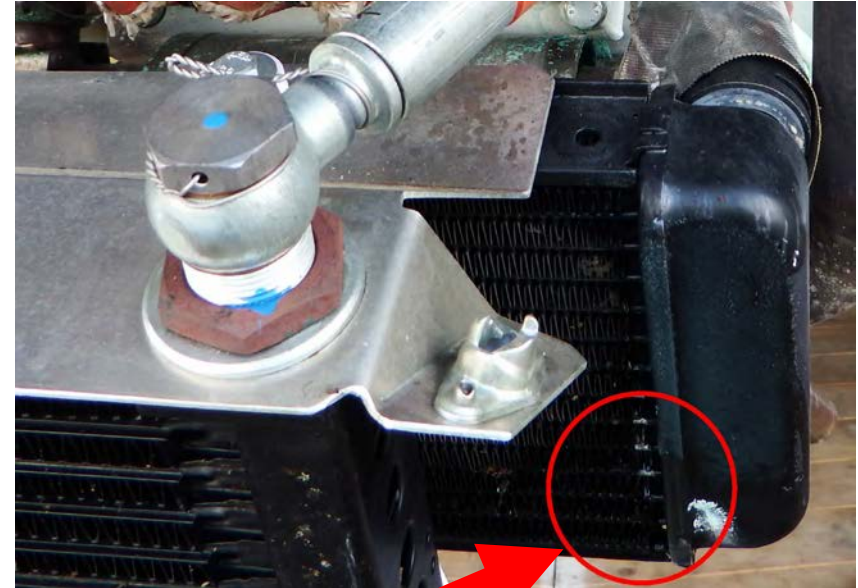
unterer Bereich des Wasserkühlers / lower area of water radiator

An incident during flight of coolant loss with subsequent engine over heating was reported. A damage of the water radiator due to chafing at the air-duct was the cause.

- (1) Inspection of water radiator and lower cowling (see pictures in annex)
- (2) In case of positive findings, trim (e.g. by grinding) GRP-web of air-duct and renew edge protection, so that a spacing of 1 up to 3 mm between radiator lower area and air-duct edge protection is ensured.
