EASA Safety Information Bulletin

SIB No.: 2014-34
Issued: 23 December 2014

Subject: **Possible Exceedance of Engine Temperature Limits of BRP-Powertrain Rotax 912 and 914 Engines**

Ref. Publication: BRP Powertrain Service Bulletin SB-912-066 and SB-914-047 (single document) dated 08 December 2014, or later approved revisions.

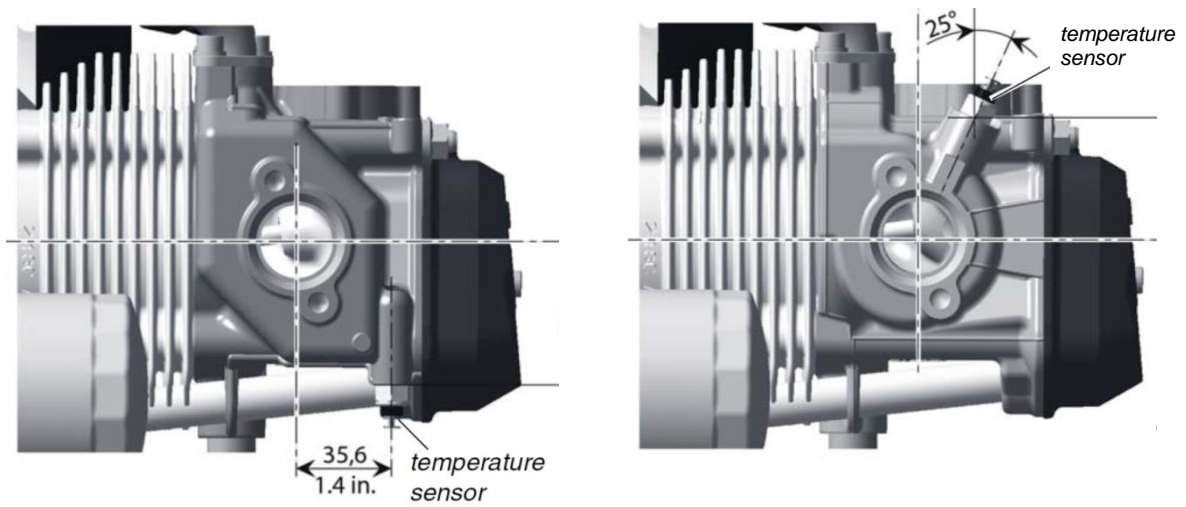
Picture 1 – CHT versus CT measurement

The reported conditions are the result of an insufficiently communicated engine design change which altered the engine/aircraft interfaces by substituting the previous cylinder head temperature (CHT) measurement (limit temperature 135°C/150°C) with a coolant temperature (CT) measurement (limit temperature 120°C).

This design change is currently not identified by the engine model designation or the engine P/N but only through the cylinder head P/N and the position of the temperature sensor:

CHT measurement → temperature sensor points downward
 CT measurement → temperature sensor points upward

Old cylinder head design, CHT measurement

New cylinder head design, CT measurement
