## **Austausch Kühlflüssigkeit** **Exchange Coolant**

Austausch der Kühlflüssigkeit gemäß Rotax Service Bulletin Nr.: 912-043

# SERVICE BULLETIN

## CHANGE OF COOLANT SPECIFICATION ON ROTAX, ENGINE TYPE 912 AND 914 (SERIES)

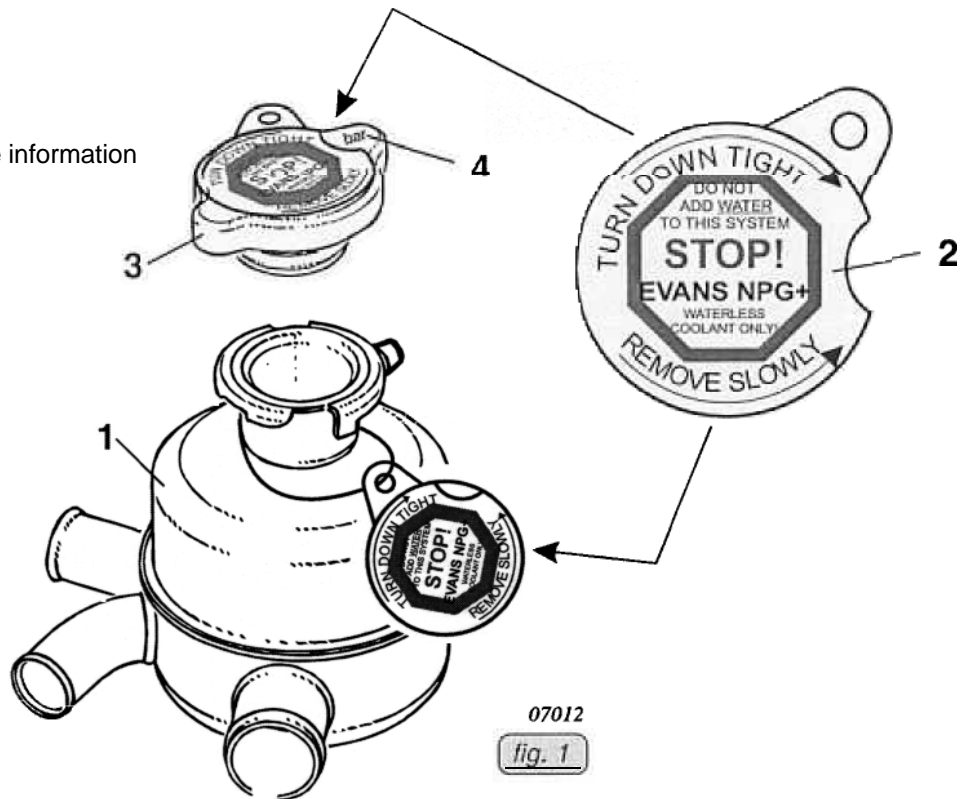
◆ NOTE: On the radiator cap (3), to identify the new coolant, the warning label (2) is to be affixed so that the opening pressure data (4) is visible.

The following drawings should provide additional information: See fig. 1

- For new engine deliveries the sticker will be temporarily attached to the expansion tank.
- The sticker has to be affixed to the radiator cap in accordance to the aircraft manufacturer's instruction.

- 1 Expansion tank
- 2 Warning sticker
- 3 Radiator cap
- 4 Excess-pressure information

(see fig. 1)

The coolant is to be replaced according to the Maintenance Manual, **current** issue.
