Aviation DOA Nr.: EASA.21J.025	Maintenance Instruction	Dokumentnummer : WA-AT01-1020-301
	Additional works for NVFR-Equipment TCDS-No.: EASA.A.527 Project-Nr.: 00219	Ausgabe: A.01 Seite: 1 von 7

1 General Information

This Maintenance Instruction contains all changes to the affected information's of the Basic Maintenance Manual, which caused by the implementation of the Major Change AT01-00219. All the additional information's relevant to the maintenance and continued airworthiness tasks of the modified aircraft are contained. The maintenance instructions contained in this instruction shall be used in conjunction with the Basic Maintenance Manual and they are an integral part of this. This maintenance instruction must be inserted in the Basic Maintenance Manual.

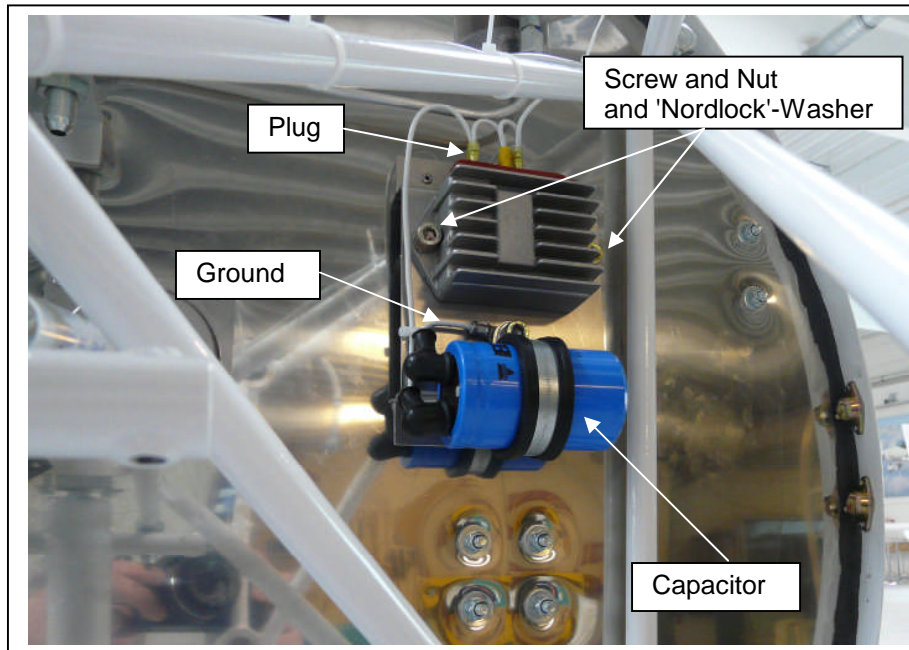
1. Disconnect all wires from the rectifier-regulator unit.
2. Remove the attachment bolt and the nuts from the mounting plate and rectifier-regulator unit. Attend to the 'Nordlock' washers.

Figure 1: Rectifier-Regulator unit with mounting plate and capacitor

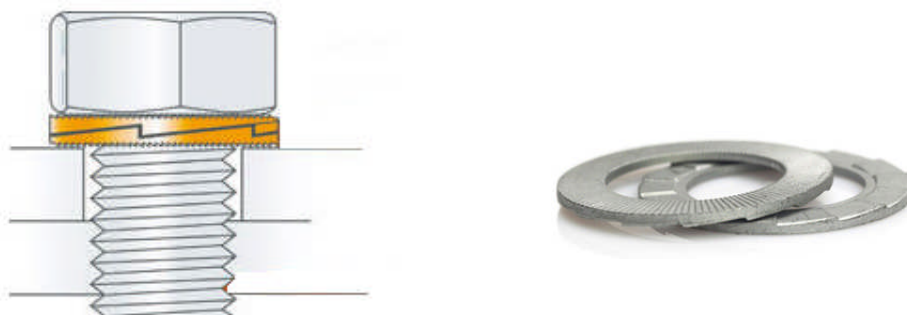
1. Install the Rectifier-Regulator unit with two screws M8x20 DIN ISO 4762, four 'Nordlock' washer and two nuts M8 DIN ISO 934 on the mounting plate. Attend to the various washers and there installation sequence.
2. Connect the wire to the rectifier-regulator unit.

Figure 2: Example for the collection of the 'Nordlock- Washer':
